BEHAVIOR AND TRAINING OF RIVER NEAR BRIDGES & BARRAGES - SOME CASE STUDY

S.K.Mazumder

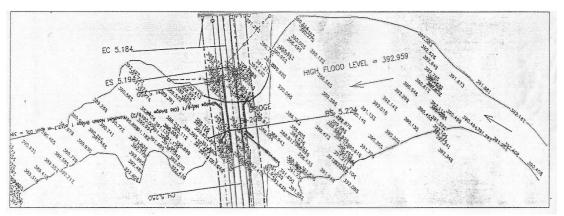
Fig. 1 Formation of a Bowl upstream and downstream of a Bridge (in a State Highway in M.P.) due to excessive restriction of waterway .The Bridge is likely to be outflanked

Depending upon the extent of constriction and location of the structure in the flood plain, the approaching river may often be unstable and asymmetric. Such unstable river may shift its course and wander anywhere within the flood plain resulting in meandering and widening of the river, localized erosion of bed and banks and a bowl like delta formation in the vicinity of these structures

(Fig.1) sometimes leading to their outflanking (photograph-1). Costly river training measures are often found necessary to protect afflux/approach embankments and arrest wild meandering and possible shift of the existing river course (flow avulsion) and outflanking of the structures. Often the river is found to breach the protection embankments resulting in flood damages and unprecedented sufferings of the people living nearby (Photographs-2 and 3).

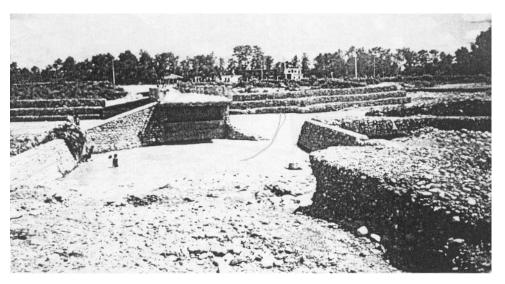
Photograph-1: Outflanking of a vented causeway on the stream 'Danab Khola' in Nepal

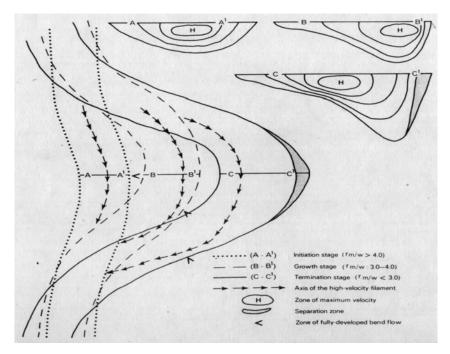
Fig. 2 Lateral Migration of Meander and Development of Stream Cross -Section in a Typical Meandering Bend with Time

increase in curvature, stronger secondary current and greater erosion of the outer bank causing migration of the meander on the outer side (Fig.2) till a state of stability occurs.

Uncontrolled and progressive erosion of outer bank causes migration of meander as shown in Fig.2. This may ultimately lead to, breaching, outflanking of hydraulic structures and flow avulsion when the river shifts its course and join other low lying rivers as observed in case of Kosi river upstream of Kosi barrage (Mazumder-1985,2009b,Chitale-2009) in August, 2008 as predicted earlier by Chitale (2000). Similar tendency is also observed in river Ganga upstream of Farakka barrage discussed afterwards under case study. The approach flow is often found to separate at the head of guide bund resulting in a skew flow both upstream and downstream of the bridge and barrage, resulting in high flow concentration and scouring. As a result, the very purpose of providing guide bund is defeated sometimes. Non-uniformity (obliquity) of approach flow causes not only deep scour due to high flow concentration, it creates large cross - slope along the bridge/barrage axis resulting in

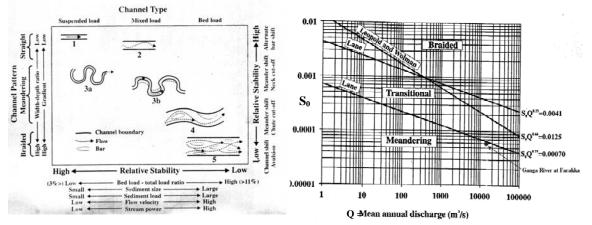
Fig. 4 Interrelation between stream forms, bed slope and mean annual discharge

Quantitative relationships between channel plan forms, bed slope (S_0) and mean annual flow (Q) are illustrated in Fig.4 (Lane -1957).

A non-cohesive stream bed composed of silts and sands is predicted to meander when

$$S_0 Q^{0.25} > 0.00070 \dots$$
 (3)

and braided when

$$S_{o} Q^{25} > 0.0041 \dots$$
 (4)

With a longitudinal bed slope of 1 in 20,000 and a mean annual flow of 12,200 cumec, the river is in a meandering state near Farakka as indicated in Fig. 4. On an average, river Ganga carries 800 million tons of sediments (Sanyal 1980) every year up to the barrage and it is estimated that approximately 13 lakh ha.m of sediments have already been deposited upstream of the barrage. Several shoals have been formed upstream of the barrage resulting in lateral flow instability, meandering and strong flow curvature resembling a braiding delta like pattern. On several occasions, the marginal embankments were breached causing unprecedented flood damages (Mazumder, 2000). The river has moved about 7 km inside Malda district as shown in Fig.8(b) wiping out thickly populated villages near the left marginal embankment. 450 people died and property worth about rupees 1000 crore was damaged in 1995 and 1998 floods alone. 27 nos. of spurs were constructed to protect the marginal embankment upstream. But the river has swallowed most of these spurs due to deep erosion near the left bank marginal embankment. At the offtake of river Pagla near Panchanandpur village, as many as 10 nos of retired embankment (Fig.9) were constructed to prevent further migration. Any avulsion of the mighty river Ganga upstream of the barrage may cause change in its course and it may capture rivers like Pagla, Kalindri and

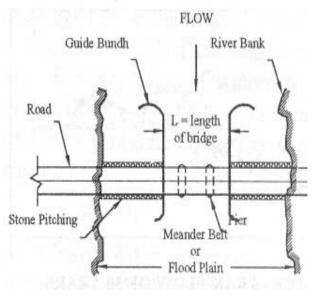
Fig. 5 Restriction of Waterway in Bridges in Flood plain with Guidebundhs and Approach Embankment

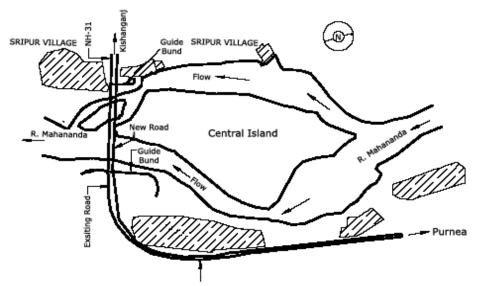
Fig.6 Plan showing Anabranching of River Mahananda u/s of Bridge on NH-31

Fig.6 and photographs 4 and 5 illustrate the river bank erosion upstream of Mahananda river bridge on NH-31 The length of the bridge is 636 m with 12 equal spans of 53 m each. It has a catchment area of about 8000 sq km up to the bridge site. Design discharge is about 5000 cumec with 50 year return period and the corresponding HFL is 36.74 m. Due to restriction of its large flood plain extending up to 3 km or more. a big central island has been formed upstream of the bridge due to deposition of sediments resulting in anabranching (bifurcation) of the river and erosion on the outer banks of the branches as shown in Fig.6. Costly river training measures consisting of permeable spurs and cut-offs were recommended to protect the villages and agricultural lands on either side of the banks and to prevent outflanking of the bridge

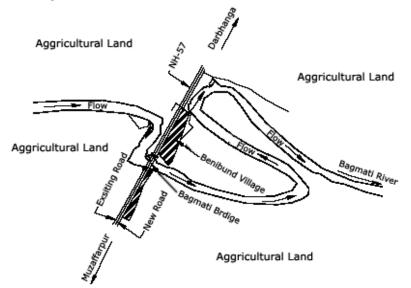
Fig.7 Plan view of River Bagmati showing Sharp Bends u/s and d/s of Bridge on NH-57

deposition of these sediments and development of sharp meandering bends as shown in photograph 6 and Fig.7, the conveying capacity of the river has reduced considerably over the years.

Due to high restriction of flood plain, the river spills its low height banks and spreads over a large width both upstream and downstream of the bridge during monsoon. The river is on the verge of forming natural cut-offs both upstream and downstream of the bridge. Training measures (Mazumder,2008) consisting of artificial cut-offs, spurs and guide bunds have been recommended to straighten the river and make it flow axially under the bridge for the safety of the bridge and the approach embankment

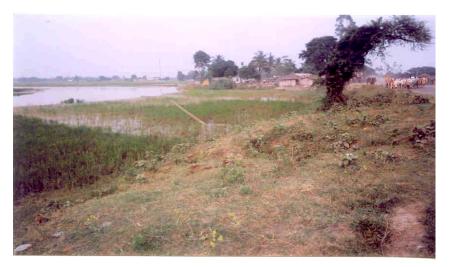
Photograph-6: Erosion on Left Bank of Bagmati River Damaging the Habitats on Outer Bank of 90⁰ Bend U/S of Bagmati Bridge

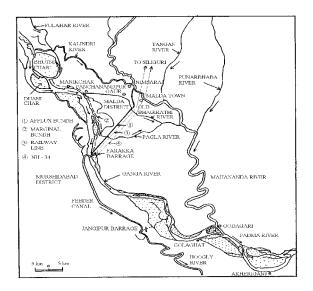
Fig.8 (a) River Ganga and its Tributories near Farakka Barrage

Fig.8(b) Change in Course of River Ganga Over the years 1923 to 1999

Mahananda. The barrage will be ineffective and it will cause colossal damage to Malda district including the National highway (NH-34), Railway line and afflux bund protecting Malda town as shown in Fig.8(a).
